A 40-Year Performance Assessment of Prestressed Concrete (PC)

I-Girder Bridges In Michigan

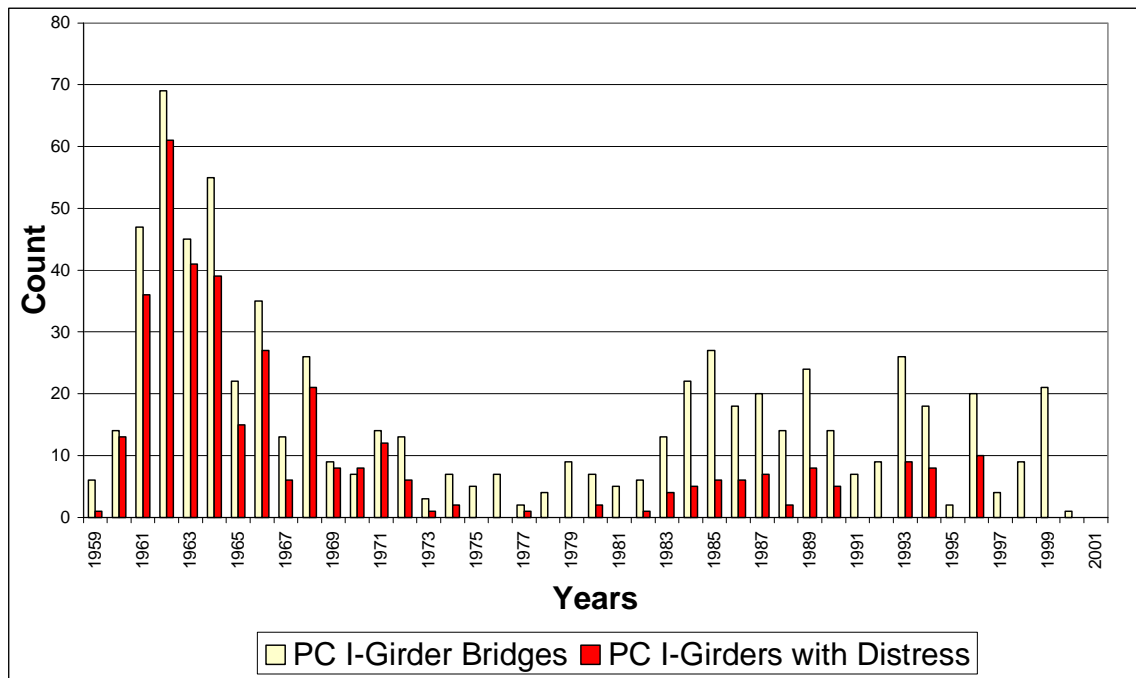
Bridge condition is documented by visual inspections and is performed on each bridge component. The Pontis inspection condition rating is assigned for each of the inspected components and is based on a scale of one (poor) to four (very good). Specifically for PC I-girder bridges, Pontis rating is provided for the barriers, expansion joints, deck, stringers, diaphragms, bearings, piers, abutments and the drainage system. Inspection comments prepared by MDOT inspectors are also documented in Pontis. A total of 499 PC I-girder bridge inspection reports were analyzed by reviewing each record and counting the occurrences of cracking, corrosion or rust, delamination and spalling reported on the girders. Data processing revealed that the delamination parameter is redundant since this phenomenon is always accompanied with the spalling. Consequently, the analysis is focused on inspector reports containing the terms of rusting and spalling. The PC-I bridges that are found to exhibit at least signs of corrosion as determined from inspectors comments are shown on a histogram in Figure 3 together with the totals.

FIGURE 3 Number of prestressed concrete I-girder bridges with distress distributed according to years.
